ABINGDON WATER TREATMENT PLANT

ABINGDON, MD

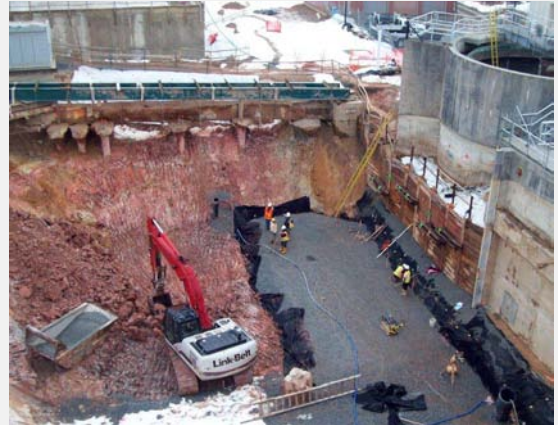
The team's solution to the problem consisted of several steps. H-beam piles were driven behind the force main fittings and $\frac{3}{4}$ -inch steel cables or rods were installed through all of the mechanical joint bolt holes to stabilize any thrust forces. Every fitting was cabled to the next one to ensure that when excavation began, the possibility of failure would be mitigated.

To support the ductbanks, 18-inch auger-cast piles were driven underneath. The piles were reinforced with steel and 4,000 psi concrete was placed in the casing, providing a solid foundation. Steel I-beams were utilized to straddle the ductbanks and grade 8 chain provided additional support between the piles.
