# CITY OF RUTLAND WATER TREATMENT FACILITY

RUTLAND, VT

## THE CHALLENGE

Immediately repair and replace the concrete roof on Rutland's water treatment plant filter structure, which was in danger of collapsing, without impacting the filters operating below.

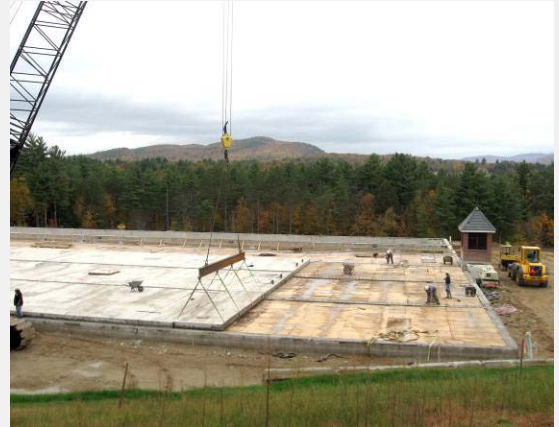
The City of Rutland had seen signs of deterioration in the 180-foot by 300-foot concrete roof over the plant's filter structure. At the City's request, PC Construction immediately mobilized and installed 600,000 cubic feet of shoring. Upon the completion of the temporary shoring, PC Construction worked closely with the City and their design consultant to find the most cost and time efficient approach to replace the existing concrete roof structure. Once the plan was in place, PC Construction began the challenging process of removing the existing roof which included 6 to 8 inches of earth and membrane roof system consisting of over 220 pieces of precast concrete plank each weighing up to 15 tons. This was all accomplished while working over the operating filters.

After the removal of the existing roof structure, PC Construction proceeded with the installation of a new precast concrete roof over the operating filters and installed a new 54,000 square foot membrane roof system. The City's water supply was neither interrupted nor compromised during construction.
